**DepEd Task Force COVID-19**  
**MEMORANDUM No. 244**  
05 November 2020

Subject: **GUIDELINES ON THE USE OF SCHOOLS AS EVACUATION**  
**CENTERS IN CONSIDERATION OF THE COVID-19**  
**PANDEMIC**

**AIDE MEMOIRE**  
4 May 2020

**URGENT NEED TO REPAIR AND REPLACE  
CEILING OF SCHOOLBUILDINGS  
CONSTRUCTED BY FROM 2014-2019**

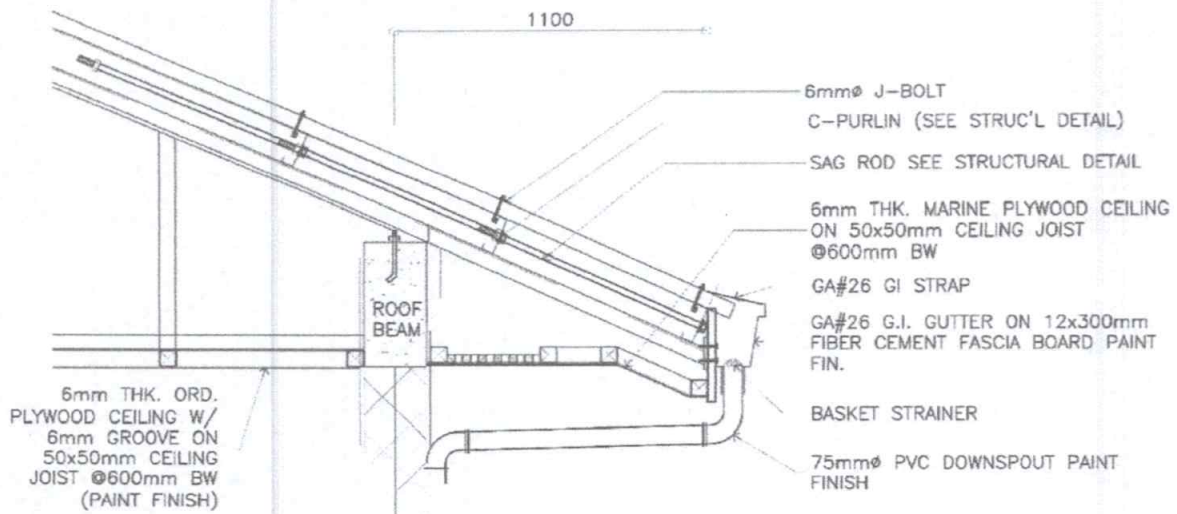
SUSPENDED CEILING TYPE  
**CEILING DETAIL**  
 NOT TO SCALE

Before 2014, DepEd already adopted the use of suspended ceilings in its standard School Building Designs composed of wooden materials specifically 50mm X 50mm ceiling hangers and ceiling joists spaced at 600mm with ordinary and marine Plywood ceiling (see picture below). The use of wood has several advantages: unlike metal, wood does not conduct heat and this increases thermal comfort or keeps classrooms cooler; plywood, unlike ficem boards, is definitely easier to work with especially when cutting manholes (or handholes) for future utility maintenance access inside ceiling (*kisame*).

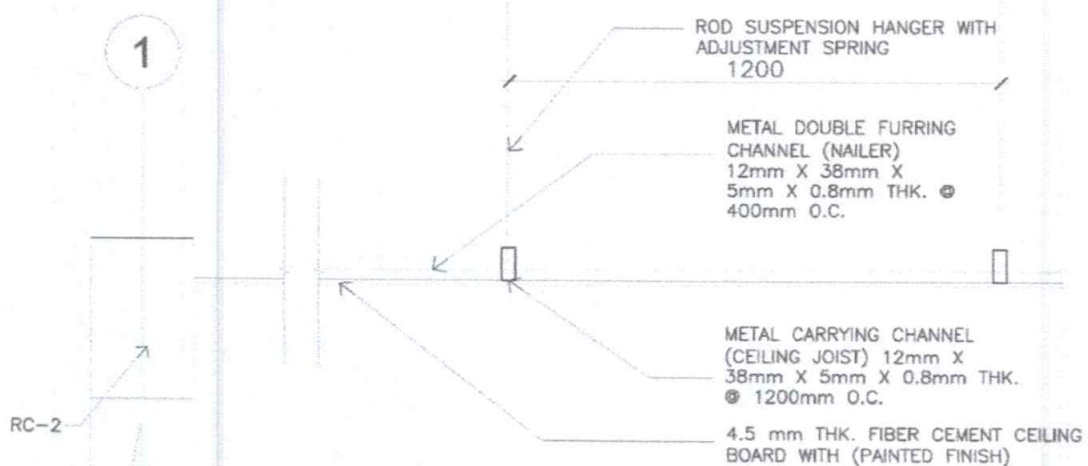
**SECTION**  
 NOT TO SCALE

When **DPWH** reviewed the designs of the school buildings in **2014**, the materials used for the ceiling was changed from the conventional wooden type ceiling hangers and joists and marine plywood, to metal furring and fiber cement ceiling board. It can be clearly seen in the design drawings that the spacing of metal furring is set at 400mm X 400mm, using metal carrying C-channels.

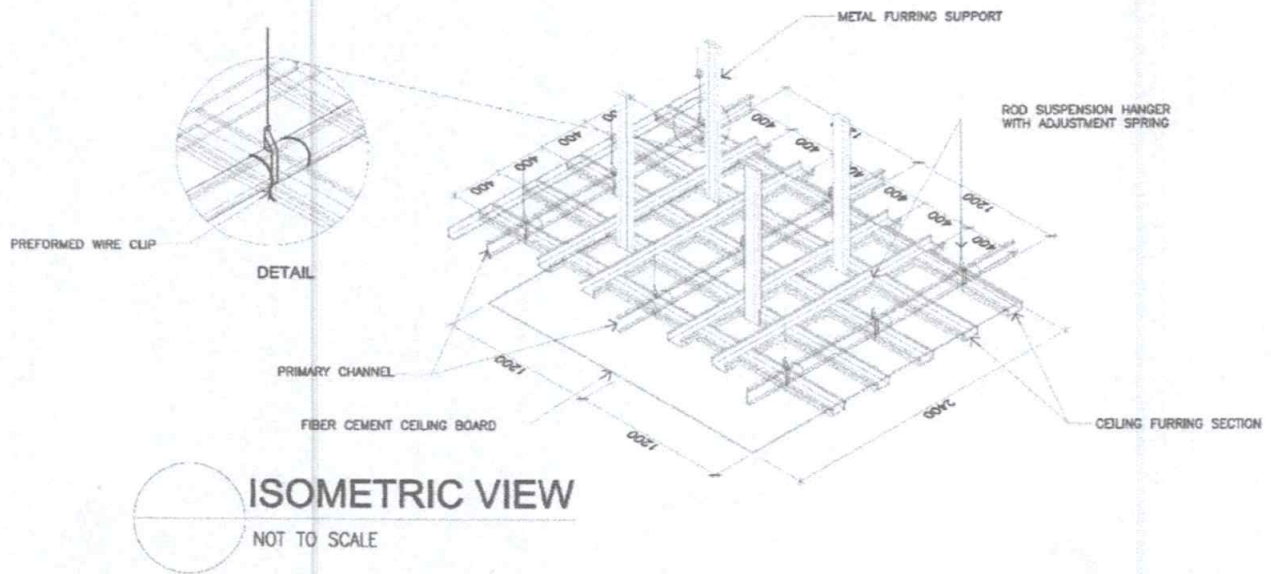
**The design specifications were apparently not followed in actual construction: not only were metal C-channels spaced farther apart, there was inadequate and fewer metal furring supports/hangers, as evidenced in the pictures of collapsed ceilings shown in the succeeding pages of this document.**

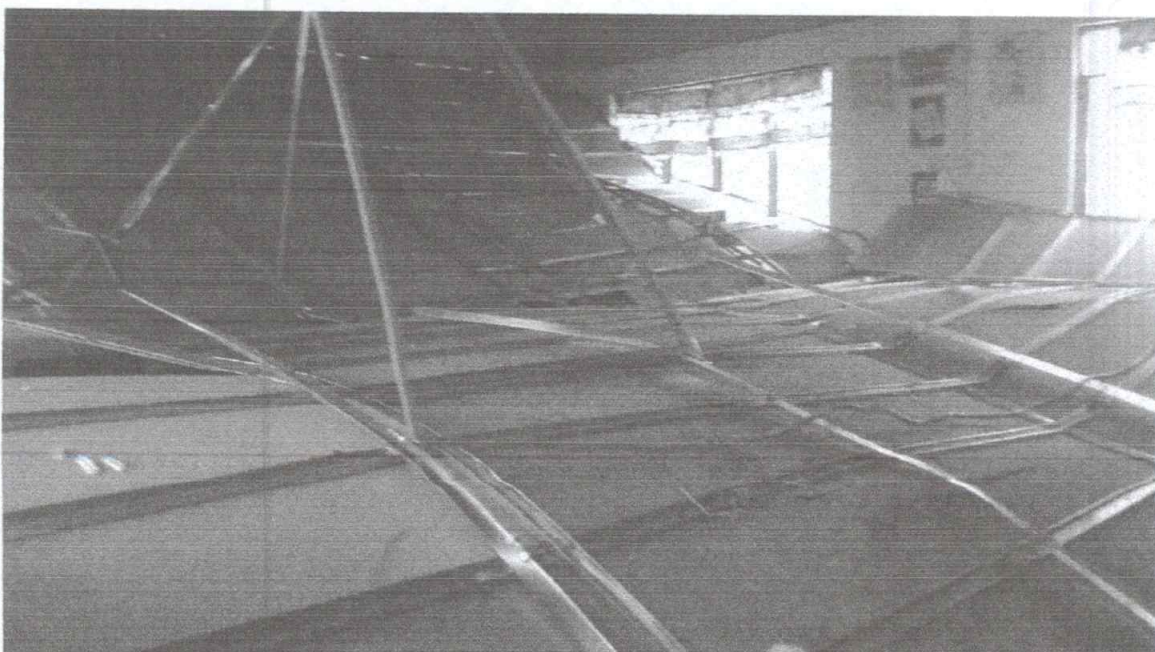
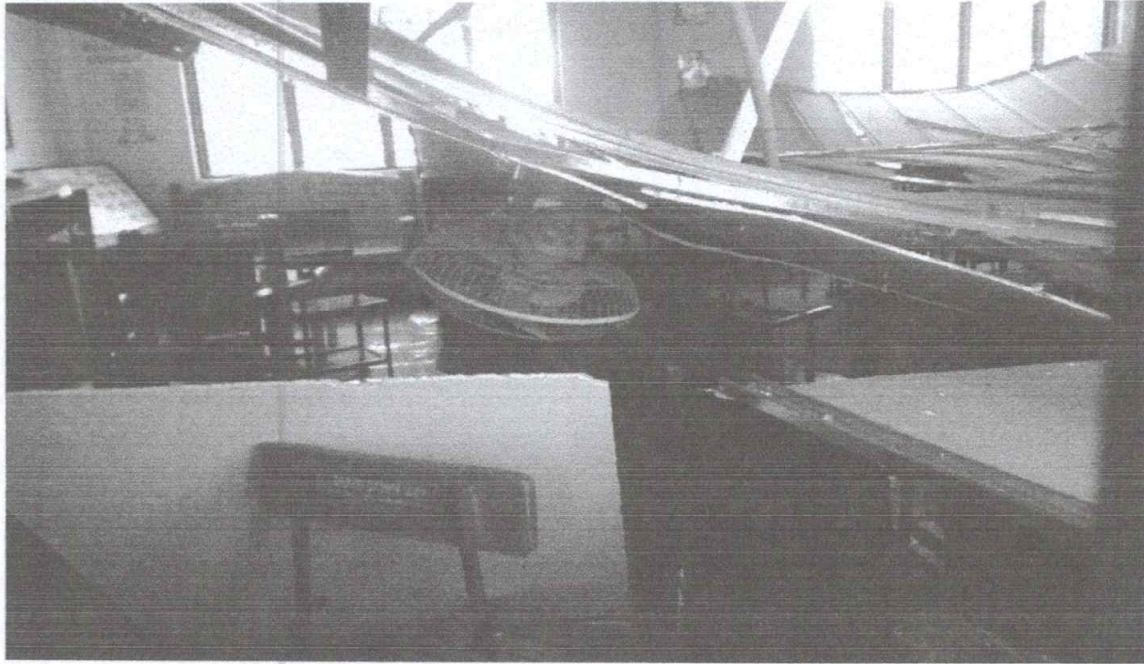
The **first incident of collapsed ceiling was reported in Ramon de Santos NHS, Cuyapo, Nueva Ecija.** The incident happened in **November 2017 under normal weather condition.** The said incident was broadcasted in local media outfits which led the DPWH contractor to shoulder the expenses of hospitalization and medicines of injured students and the reconstruction of the collapsed ceiling without any additional cost to the government.

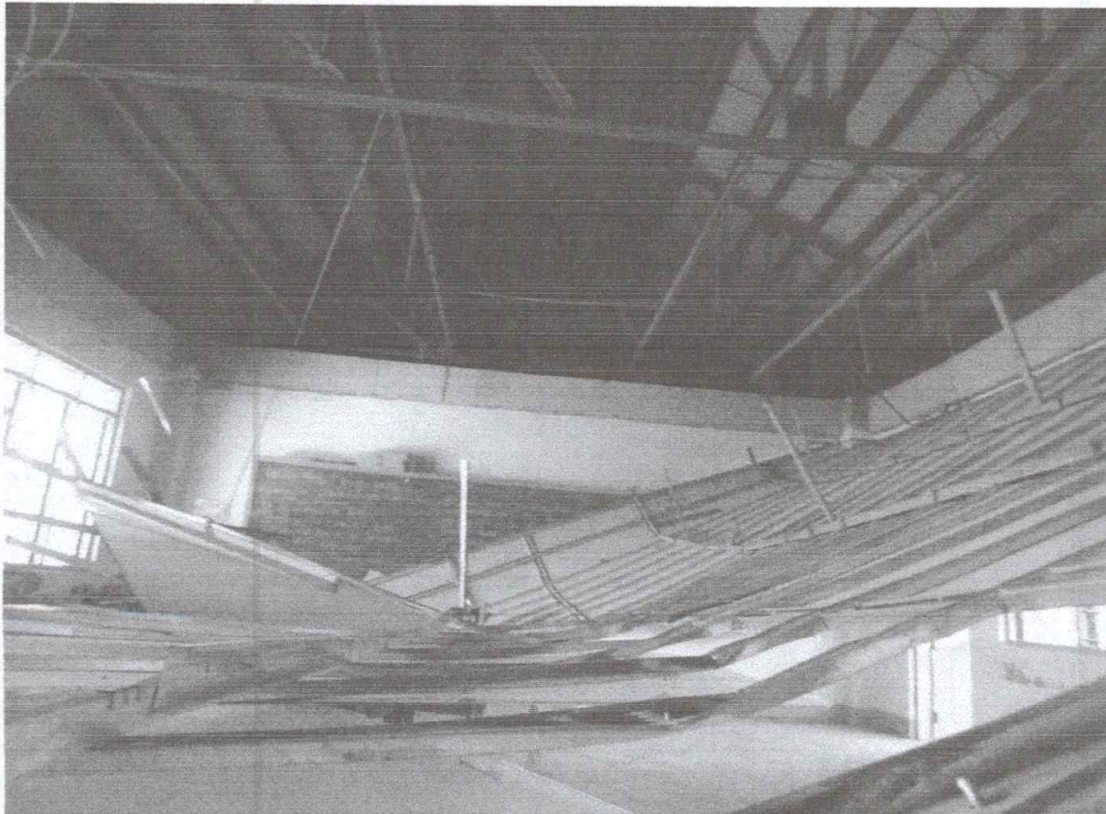
**Domingo Lacson National High School**

**Several incidents followed and were recorded** by the Regional and Division Offices of DepEd particularly **after a series of earthquakes and other natural calamities struck the country.**

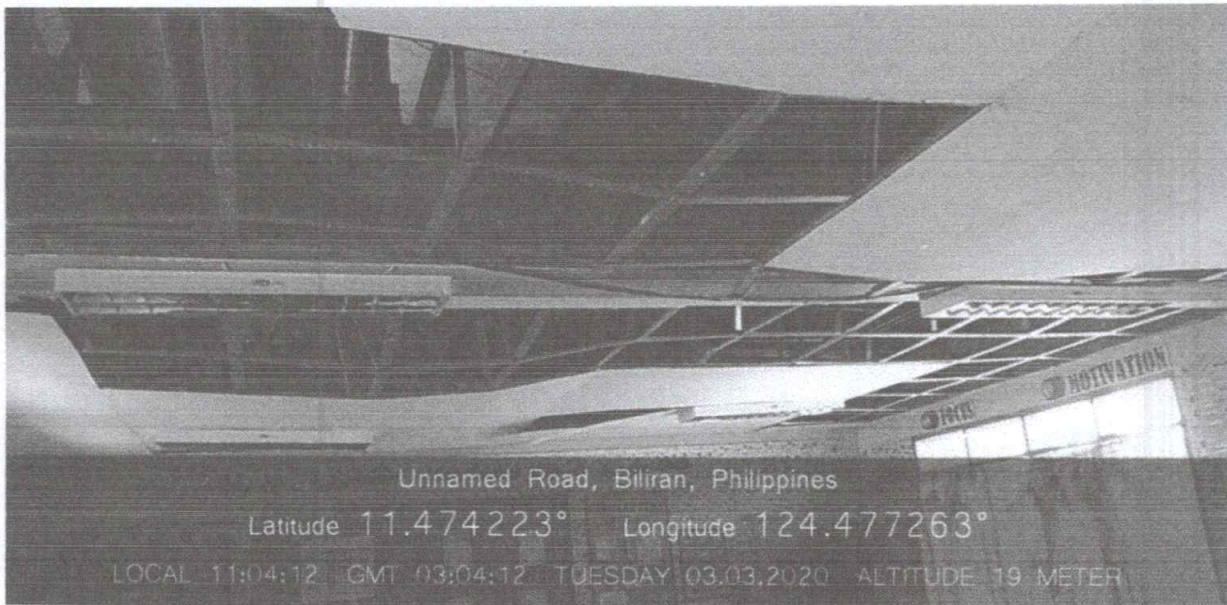
**Collapsed Ceilings due to Earthquakes**

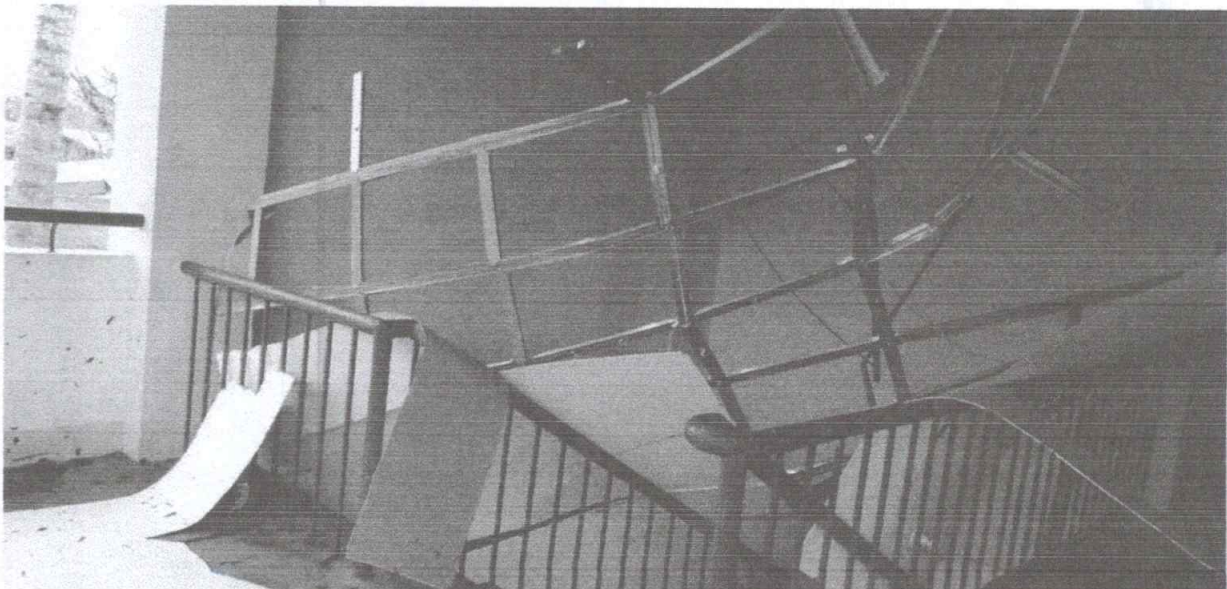
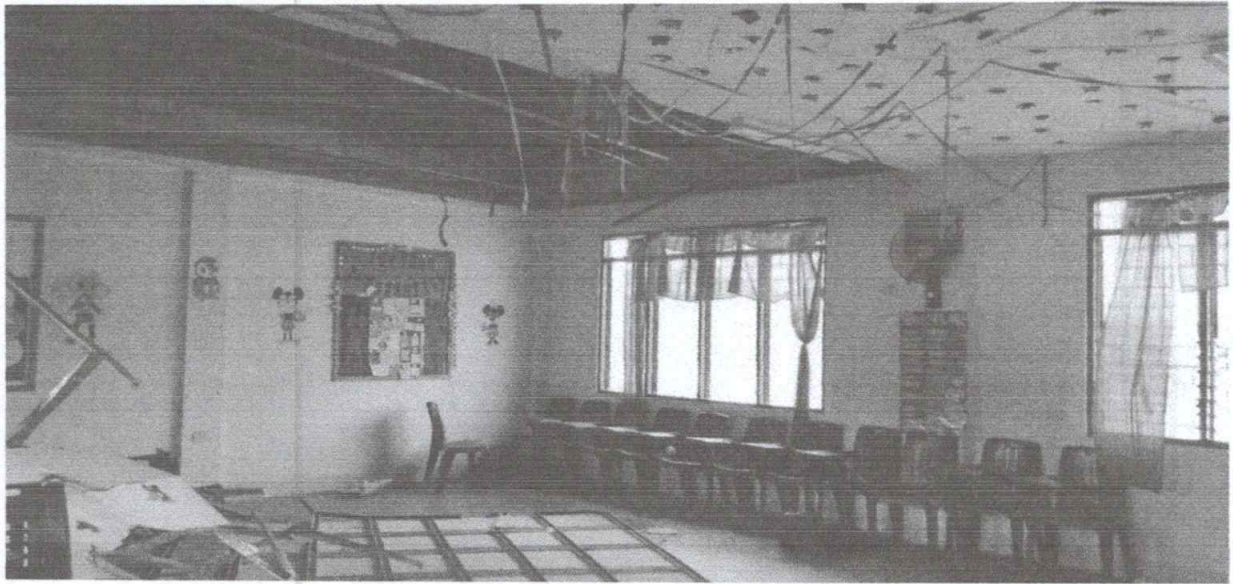
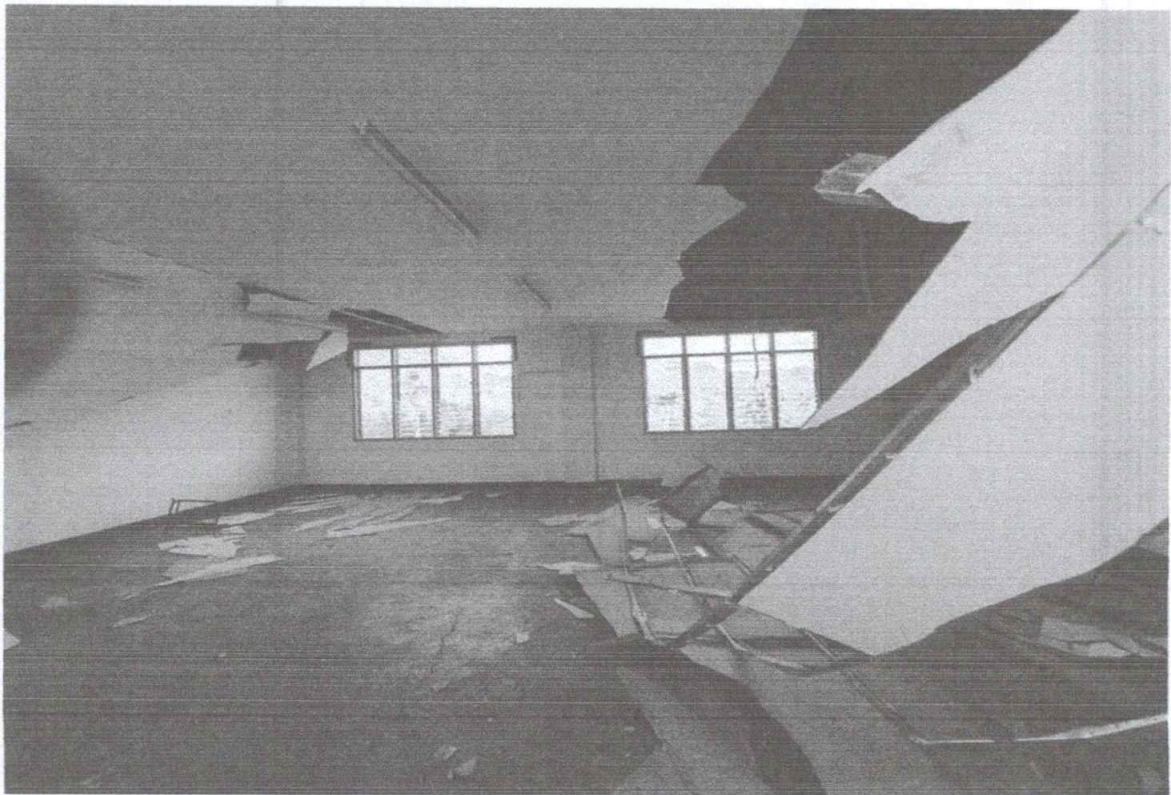
**Collapsed Ceiling due to Typhoons**

Matacon NHS, Albay collapsed ceiling due to Typhoon Tisoy
